## Transparency International - Bulgaria

### REPORT

the Public Procurement Procedure for the Design and Works of Struma Motorway, Lot 3.1 Zheleznitsa Tunnel with three lots, opened with the Decision no. 115/17.10.2017

#### PHASE IV

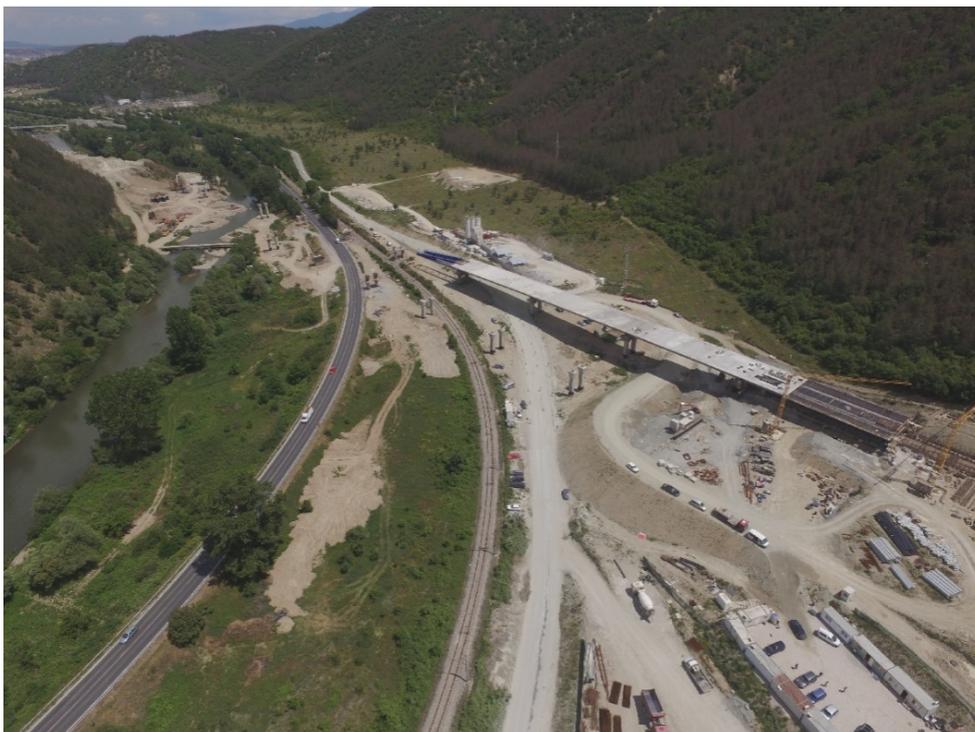
Photograph 1. Path of the large facilities over the railway line and E-79

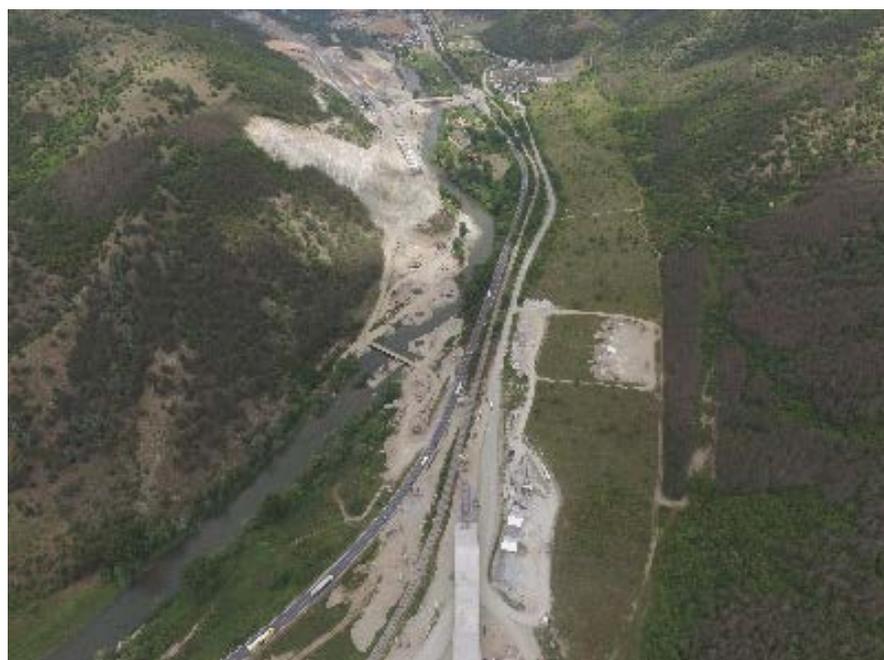
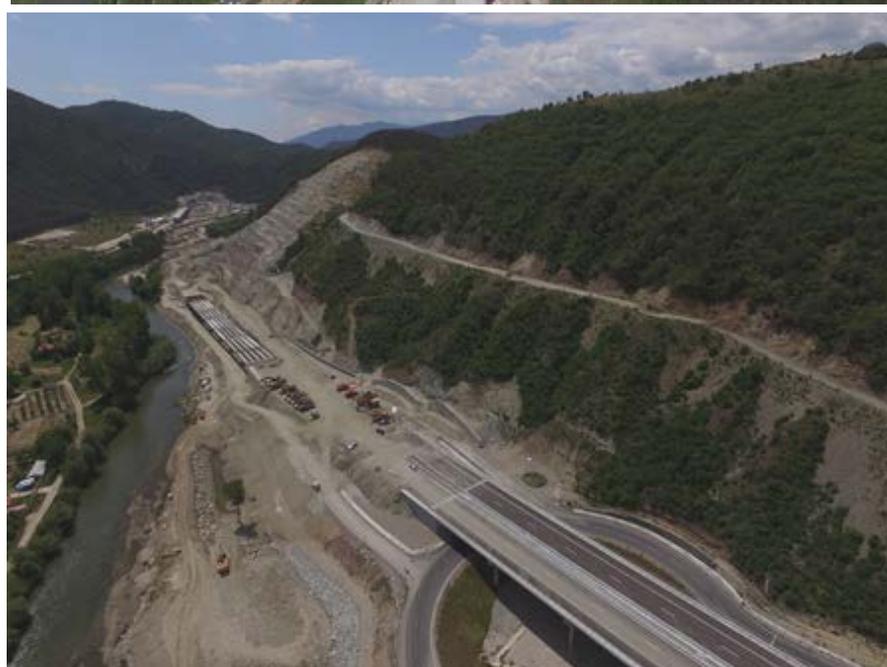
**2.** The circumstance that the data from the geological examination at the conceptual design stage differ from what was established in the process of development of the technical design poses difficulties in the design process, all procedures related to it and any following actions. For example, the RIA ETEC reviewed a geological report for this section for the third time and, respectively, considered proposed technical solutions to reinforce the slope three times.

*Photographs 2 and 3. The area between the preceding section and subsection 1*

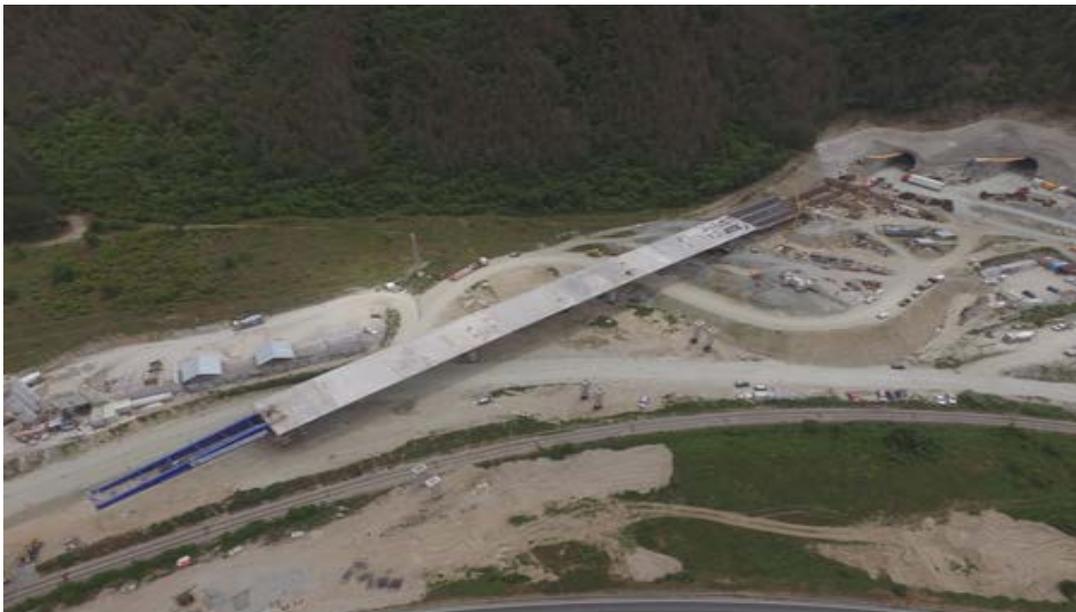
*Photograph 4. Construction works in the left lane*

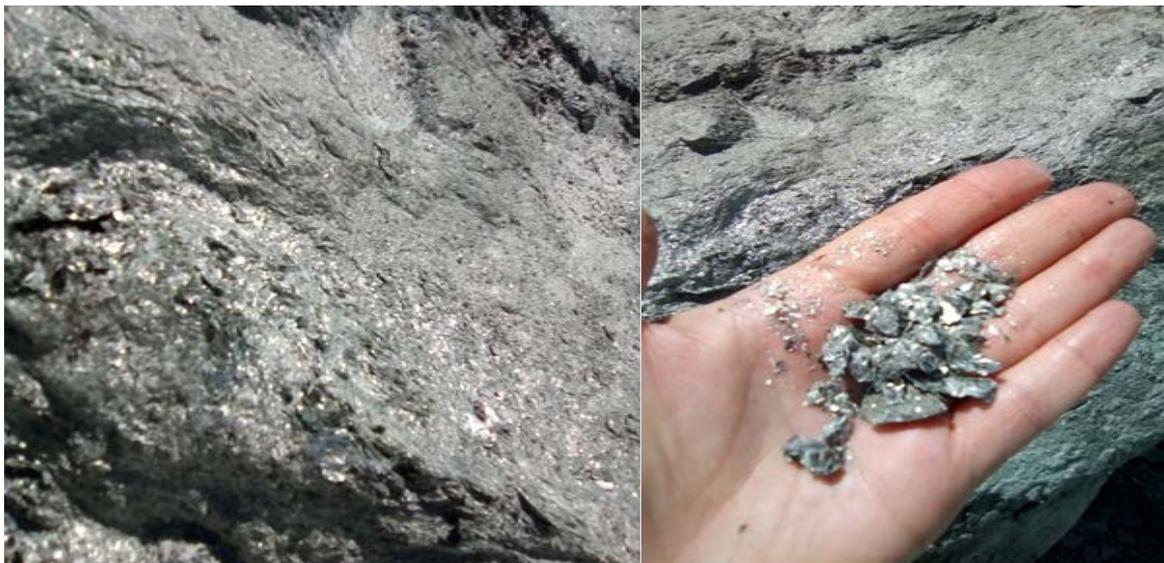
deformations were increasing. The representatives of the contractor confirmed that zones with unstable ground mass had been reached. These are ground, tectonically processed and, respectively, unstable areas in the rock mass. The movement processes of the ground mass are monitored closely, and measurements are made. After the intensive rainfall, an increase in deformations and water inflow were found.

69. The on-site inspection from the south entry confirmed the findings that an area of unstable ground mass had been reached.

*Photographs 5 and 6. Rock samples taken from the tunnel section bored (about 538 m): mica gneiss, tectonically processed, mylonitised.*

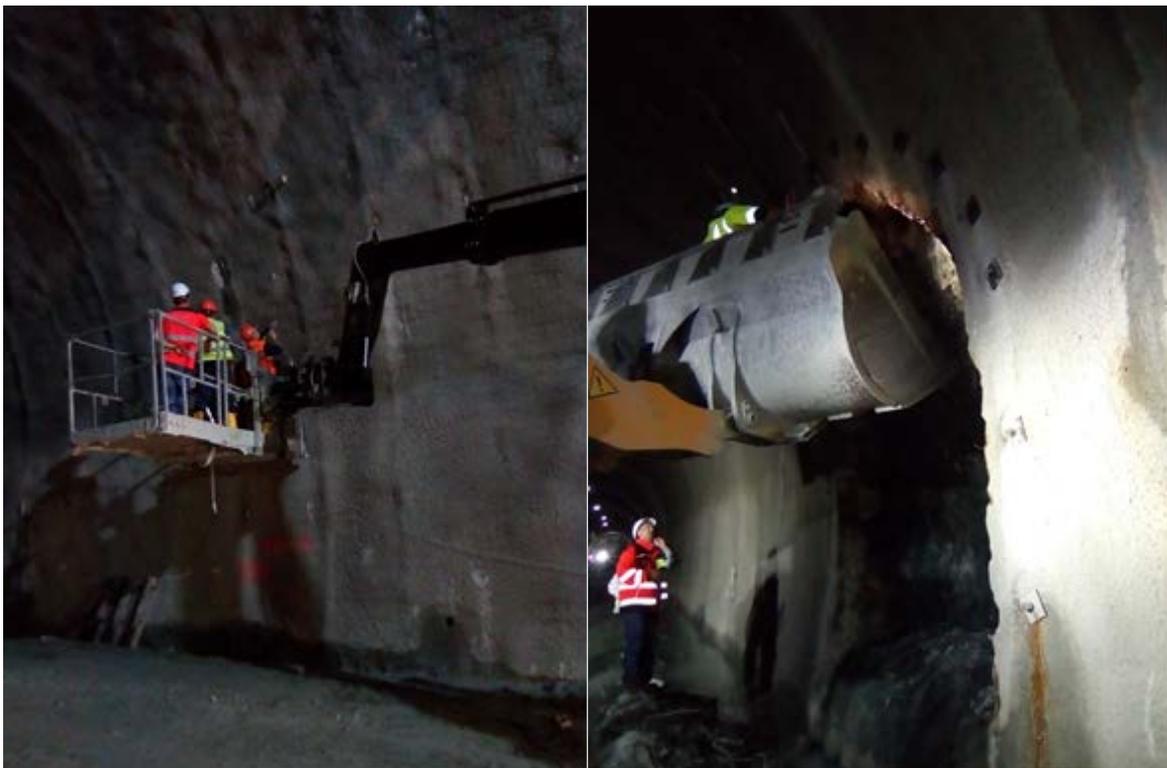
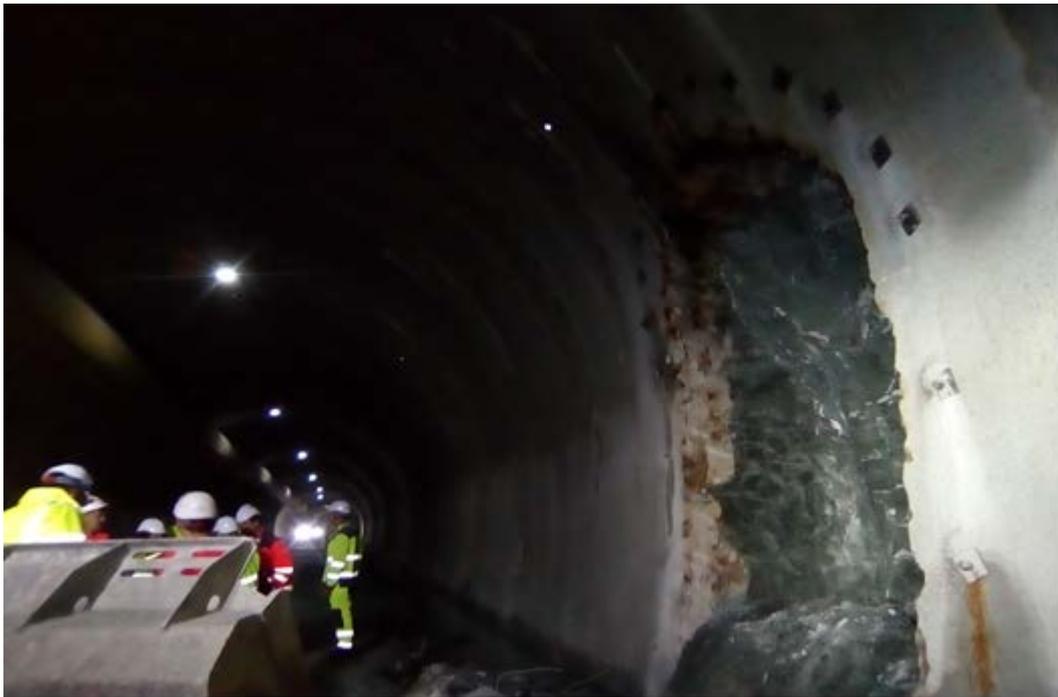
75. During the on-site visit, the observer had the opportunity to attend the taking of a sample from the thickness of the concrete. The profile sample was taken in the south tunnel, at m 279.90. While the sample taking was underway, a parallel measurement of the thickness of the concrete at the emergency exit of the left tunnel was carried out. The measurement showed good performance covering the benchmarks set<sup>16</sup>.

*Photographs 7, 8 and 9. Sample taking at m 279.90 in the right tunnel tube. Measurement at the emergency exit of the left tunnel*

<sup>16</sup> The thickness at the stross on one side has the following values: 50 cm; 52 cm and 45 cm (significantly higher than the required 35 cm); on the other side, the values are: 32 cm, 43 cm, 32 cm. The measurement at the calotte also shows good performance: 60 cm and 82 cm.

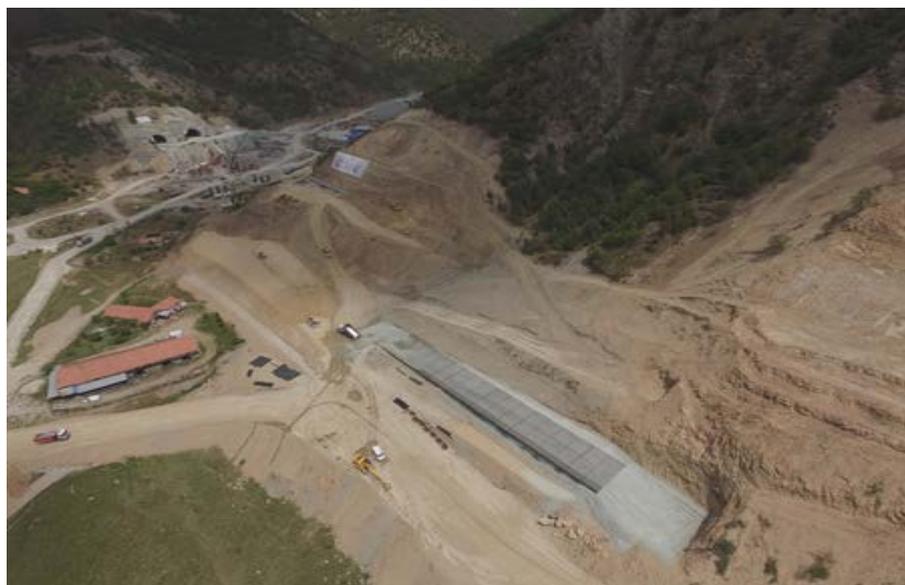
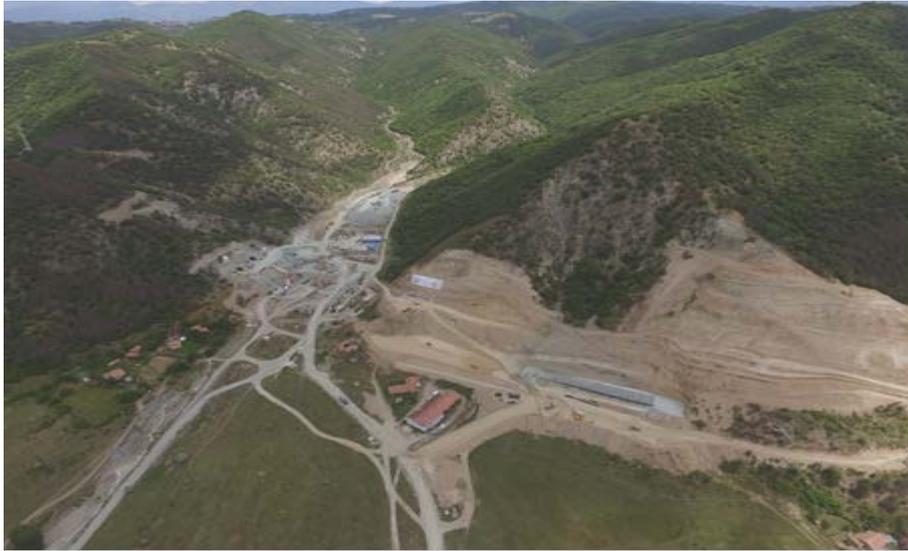
*Photographs 10 and 11. Subsection 3 on the side located next to the future tunnel*

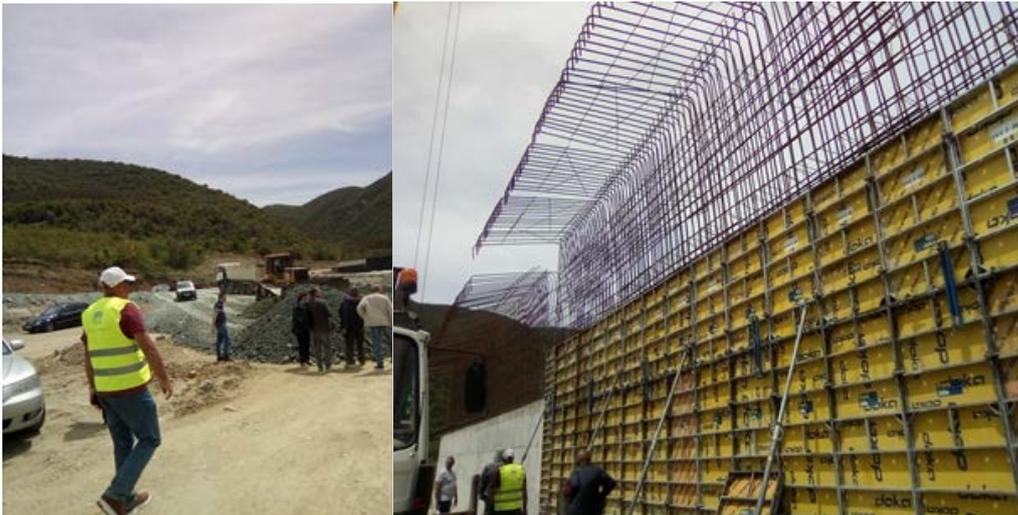
*Photographs 12 and 13. Laying the foundation of the road. Building an emergency connection*
